Arboricultural Report

Tree Survey,
Arboricultural Impact Assessment &
Arboricultural Method Statement

Grange Road

230122-PD-11

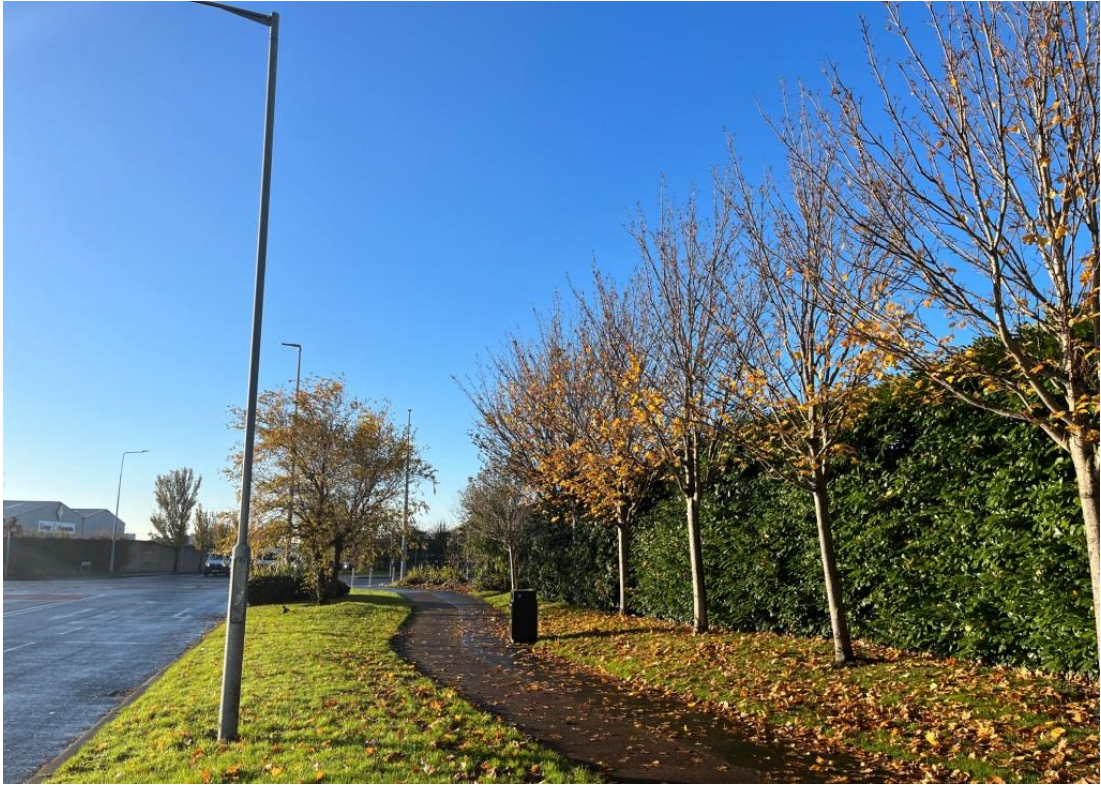
Photo 1: View of the trees and hedgerow (T1 to H17) located adjacent to the eastern boundary of the site. These trees and hedgerow are proposed to be retained.

- 6.10 **Tree protection measures** – The hedgerow and tree line located adjacent to the eastern boundary can be successfully protected during the proposed development works by using robust fencing measures which comply with the recommendations outlined within BS5837:2012. For details of all tree protection measures required during construction operations, please refer to the Tree Protection Plan located at Appendix B.

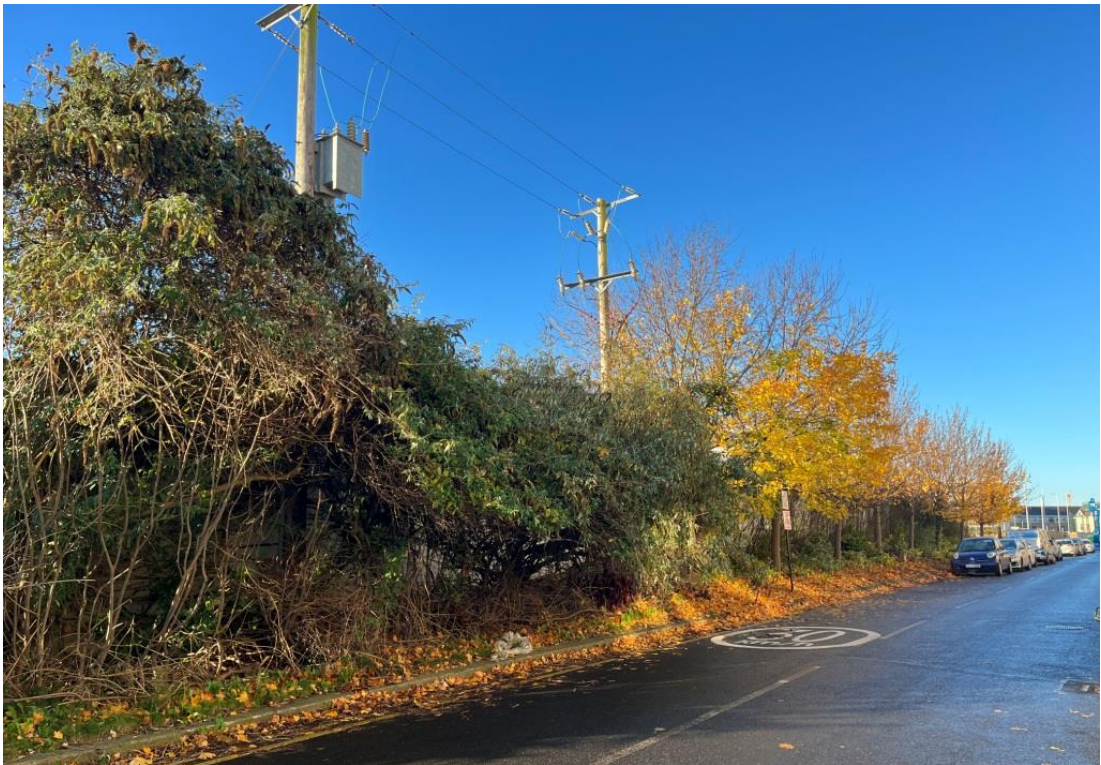
Photo 2: View of the trees and hedgerow (T18 to G27) located adjacent to the northern boundary of the site. These trees and hedgerow are proposed to be removed to facilitate the new footpath and cycle path.

- 6.2 The proposed removals are required to facilitate the construction of a new public footpath and cycle path that connects the adjacent school with Longfield Road. The loss of these trees will have an initial visual impact within the immediate local area due to their prominent location.

- 6.3 The development is proposing to plant new high-quality trees within the Applicant Site. This planting may not directly replace the loss of trees along the northern boundary; however, across the scheme, it will mitigate the loss of canopy cover and even enhance it in the future.
